Egli, Fischer & Co. AG Zurich
 CH-8022 Zurich

Empa Report No. 438'171/E

Testing assignment: Fatigue test on CLIC-plastic pipe clamps
Test object: CLIC- Plastic pipe clamps

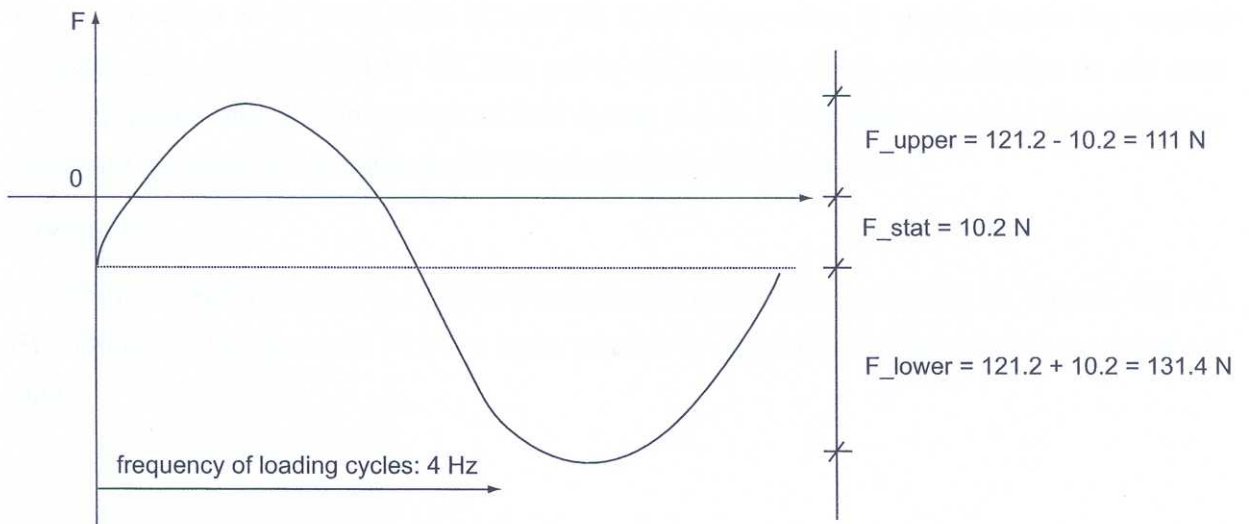
Abb. 1: Principle load during the fatigue tests.

This force was assumed as load amplitude. Friction effects, which reduce the dynamic load, remained unconsidered. One meter communication cable weighted 1033 g. This resulted in an extra static load of:

The load value was used as off-set value for the dynamic loading. The frequency of the sinus load was 4 Hz. The number of load cycles was 2 Mio. A sample (test 1) was tested in mounting direction (fig. 2), a second sample (test 2) was loaded vertically to it (fig: 3). The second test serves as evidence of the resistance of the catch of the pipe clamps.

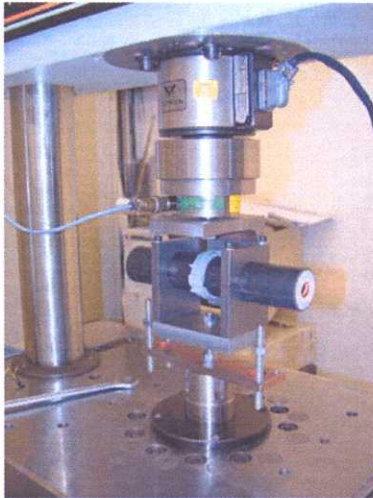
Fig. 2: Fatigue test in the testing machine Instron, sample 1.

The first pipe clamp (fig. 2) was tested by 3 Mio. load changes. In the following static test (fig 5, 6) it showed a residual strength of 1.57 kN. The second pipe clamp, shifted in its loading direction by 90° (fig. 3), was tested by 2.9 Mio load changes. In the following static test (fig. 7) it showed a remaining breaking load of 1.84 kN. After the fatigue tests, no white discoloration was visible, which is common sign of fatigue of polyamide plastics.

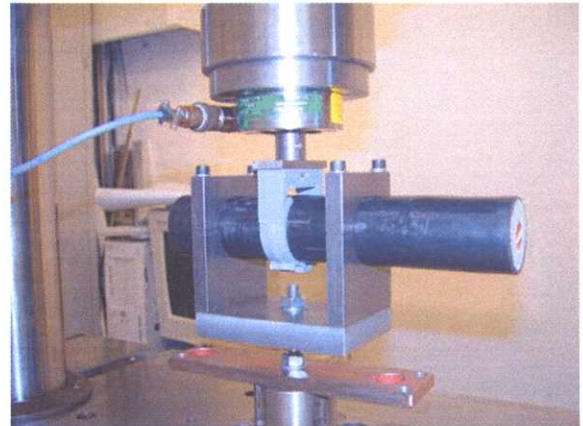
Fig. 3: Fatigue test, pipe clamp shifted by 90°, in the testing machine Instron, sample 2.

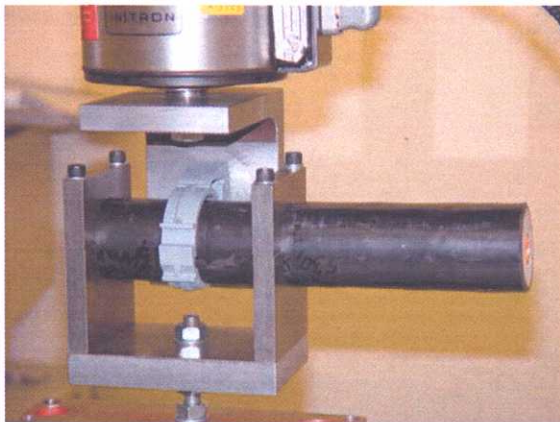
Fig. 4: Static rupture test, test machine Instron, without previous fatigue, sample 3.

On May 31, 2005, three not loaded tubing clamps, were tested regarding their load carrying behavior. The tests were performed in the testing machine Instron 1273 with a load cell (max. load 25kN), SOP-No. A-4031. (fig. 4). After the fatigue tests, the pipe clamps subjected to the fatigue tests were tested up to failure, to determine the residual strength. The tests were performed in the testing machine Zwick / Z010, ID 32782 and with the load cell (max. force 10 kN), SOP-No. A-5050. The deformation rate for all static tests was 5mm / min.

Sample 3:	1.38 kN
Sample 4:	1.39 kN
Sample 5:	1.56 kN .

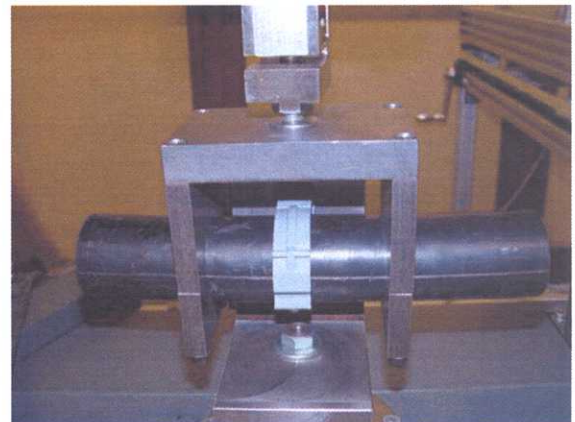
Fig. 5: Static rupture test, test machine Zwick, with previous fatigue, sample 1.

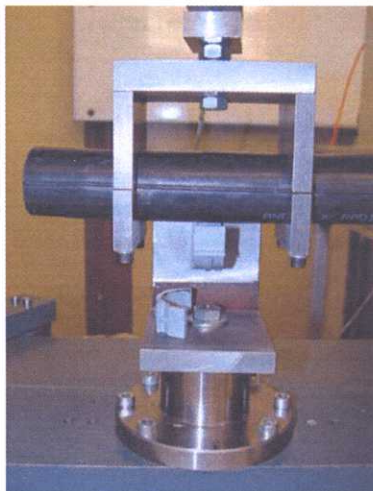
Fig. 6: sample 1 after static rupture test.

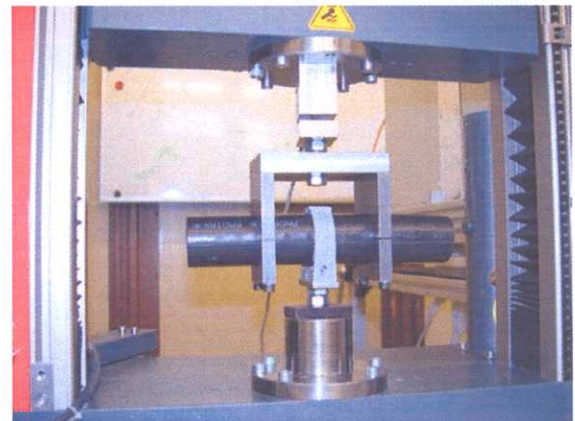
Fig. 7: Static rupture test, pipe clamp shifted by 90°, after previous fatigue, sample 2.
